MSMEC Pole Maps Update – Analysis Overview

Data analysis compiled through: Mar 3, 2024

Project completion total (entire burn area): **77% Completed**

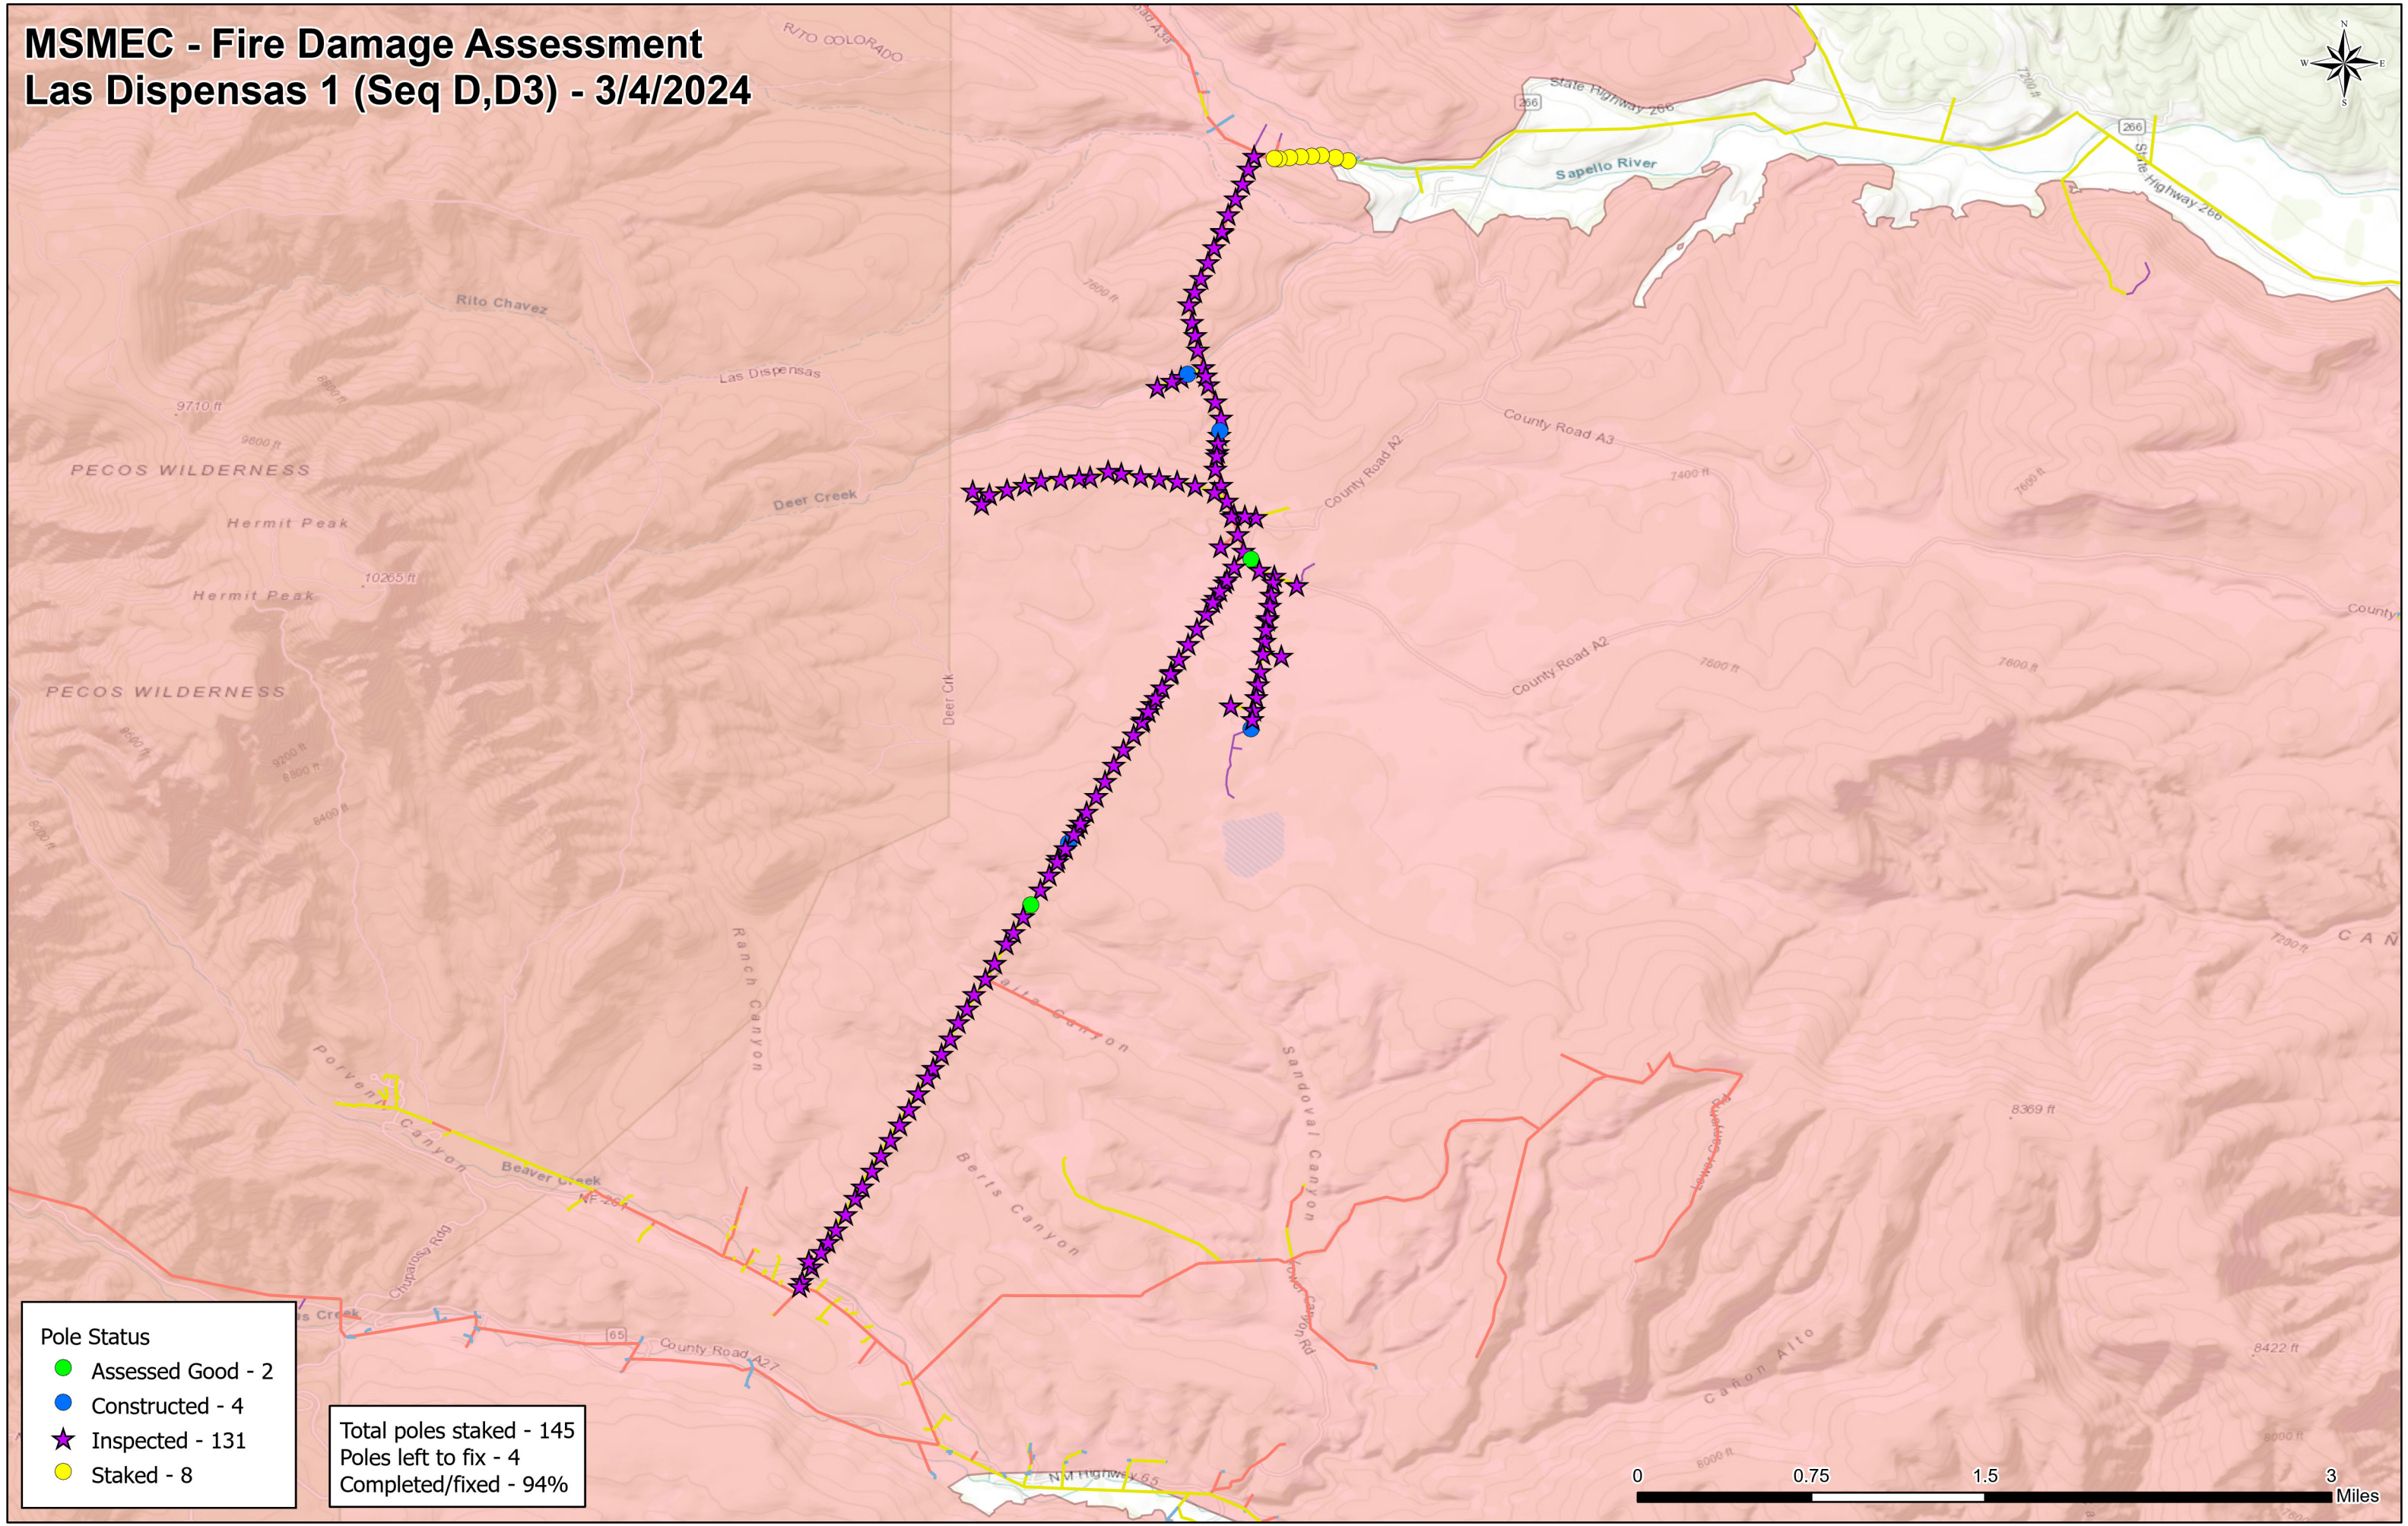
MSMEC - Fire Damage Assessment
Las Dispensas 1 (Seq D,D3) - 3/4/2024

- Assessed Good - 2
- Constructed - 4
- Inspected - 131
- Staked - 8

Total poles staked - 145
Poles left to fix - 4
Completed/fixed - 94%

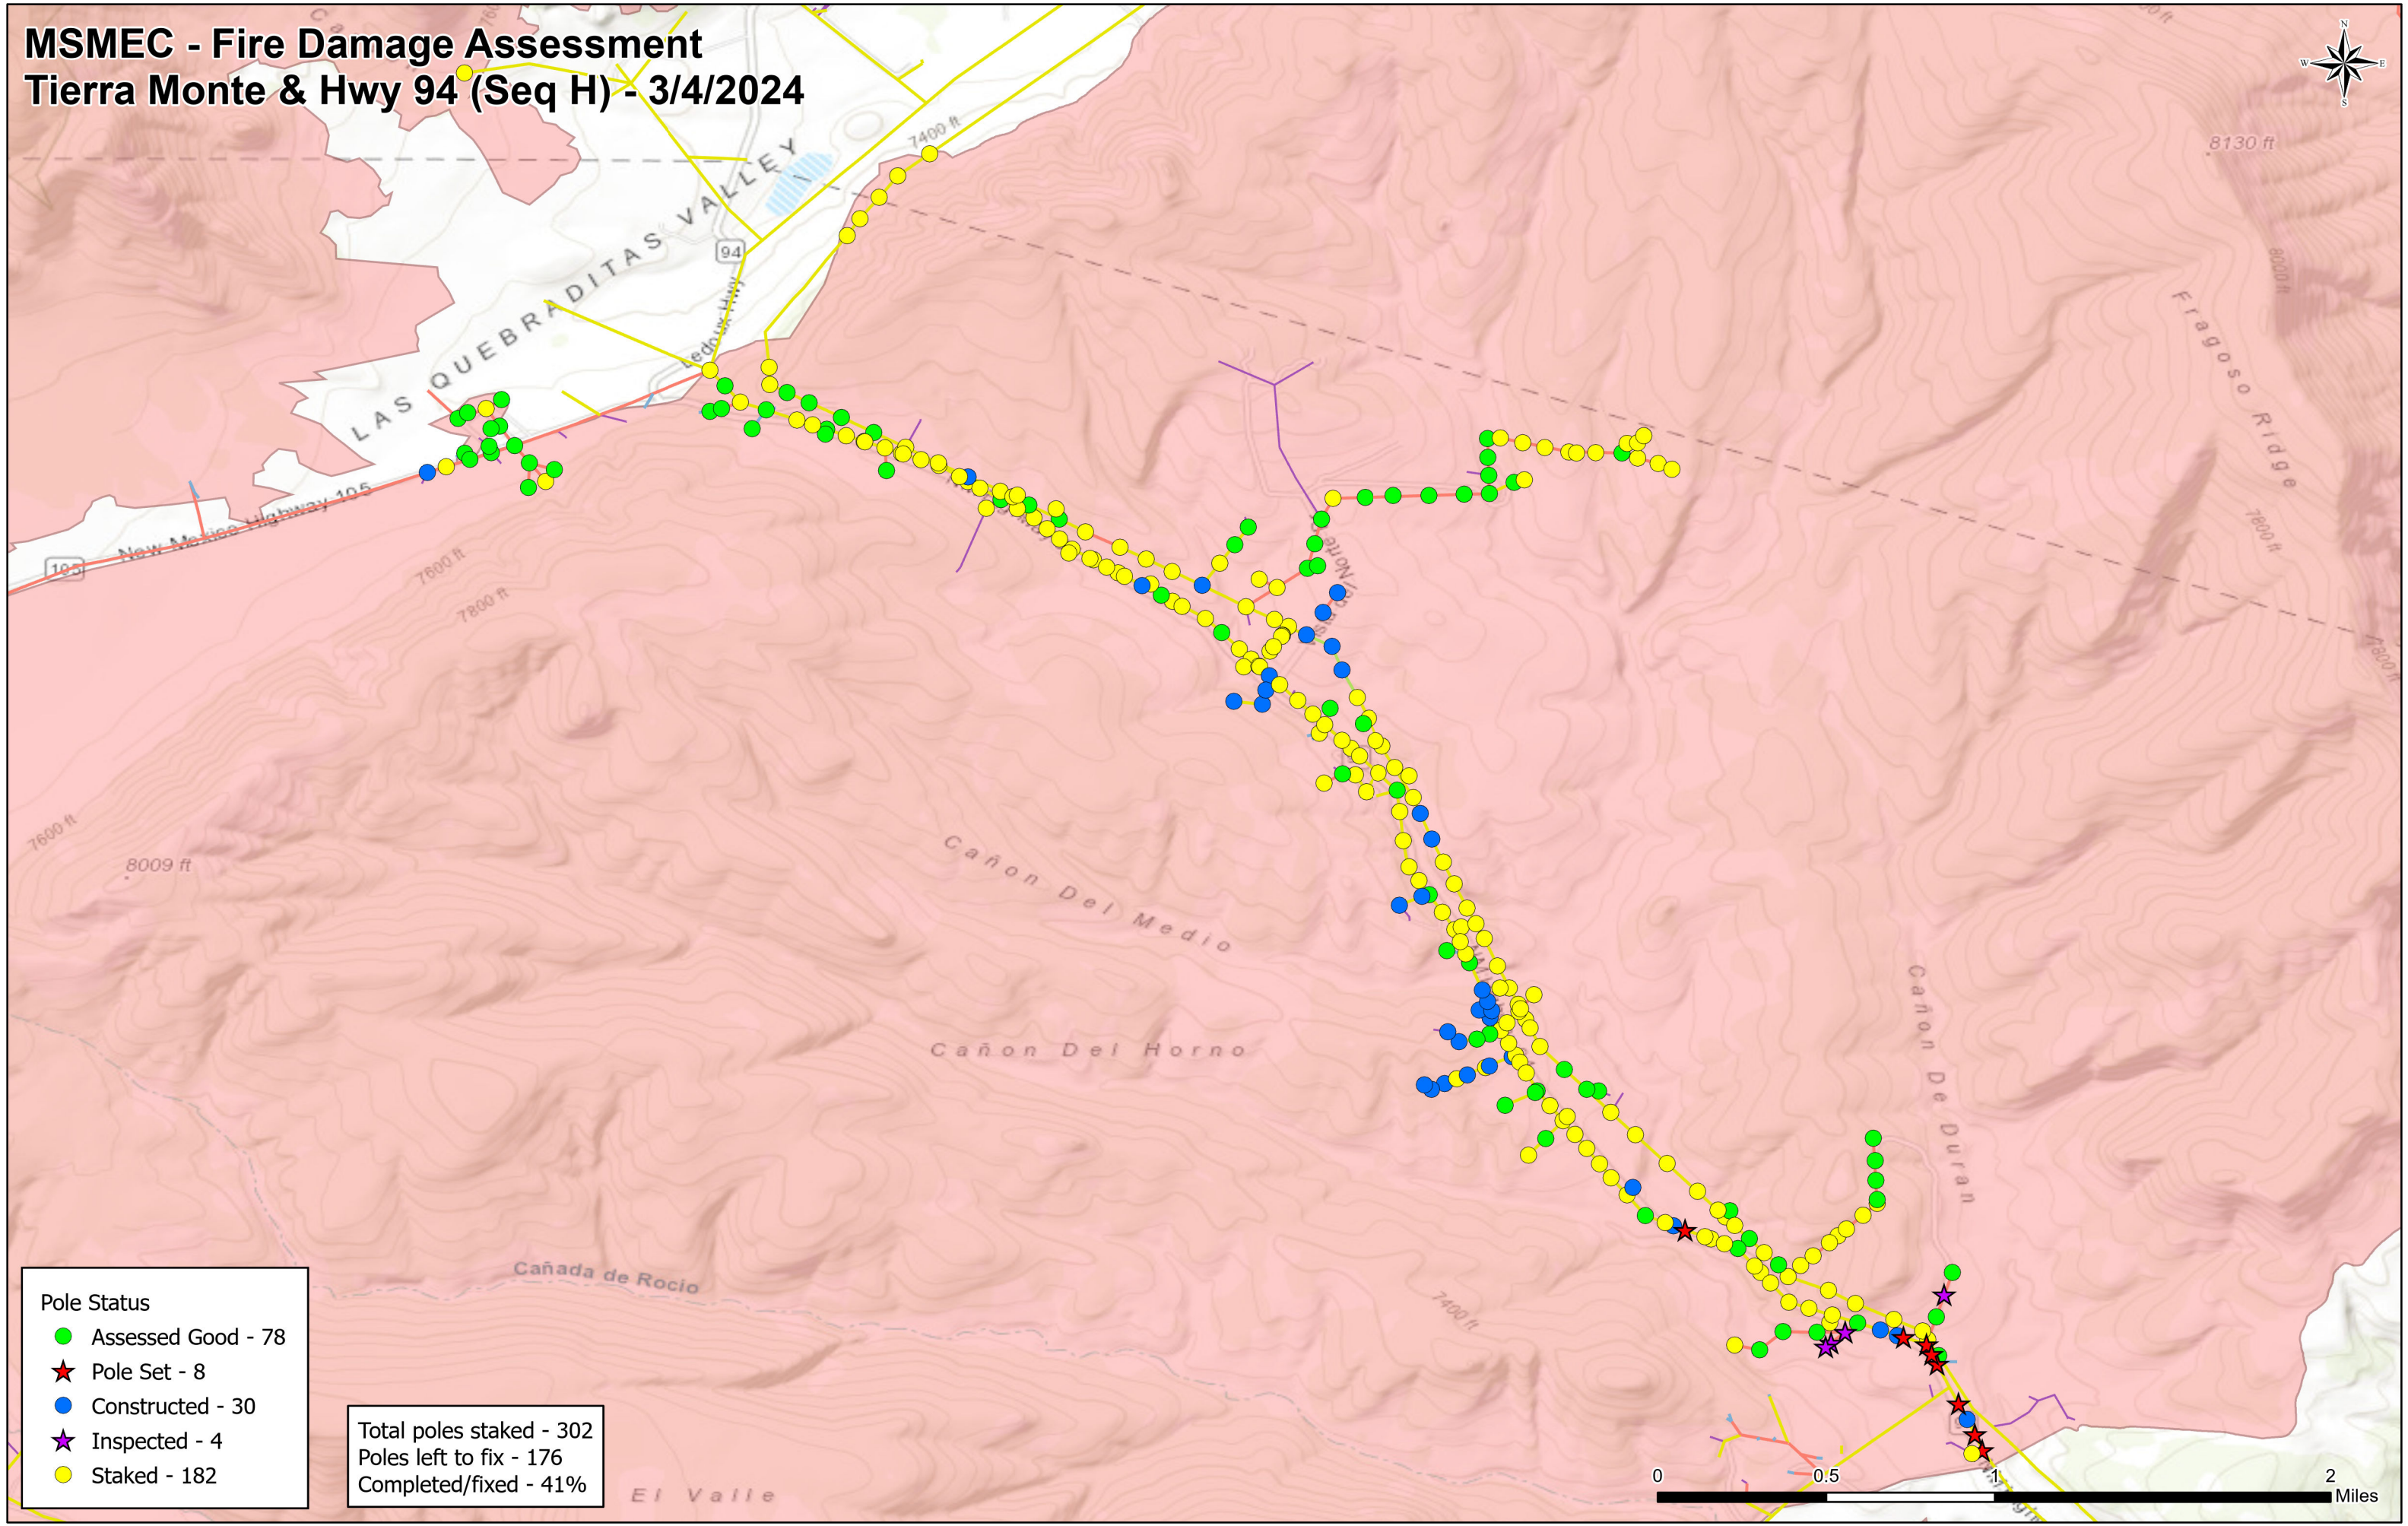
**MSMEC - Fire Damage Assessment
Tierra Monte & Hwy 94 (Seq H) - 3/4/2024**

- Assessed Good - 78
- Pole Set - 8
- Constructed - 30
- Inspected - 4
- Staked - 182

Total poles staked - 302
Poles left to fix - 176
Completed/fixed - 41%

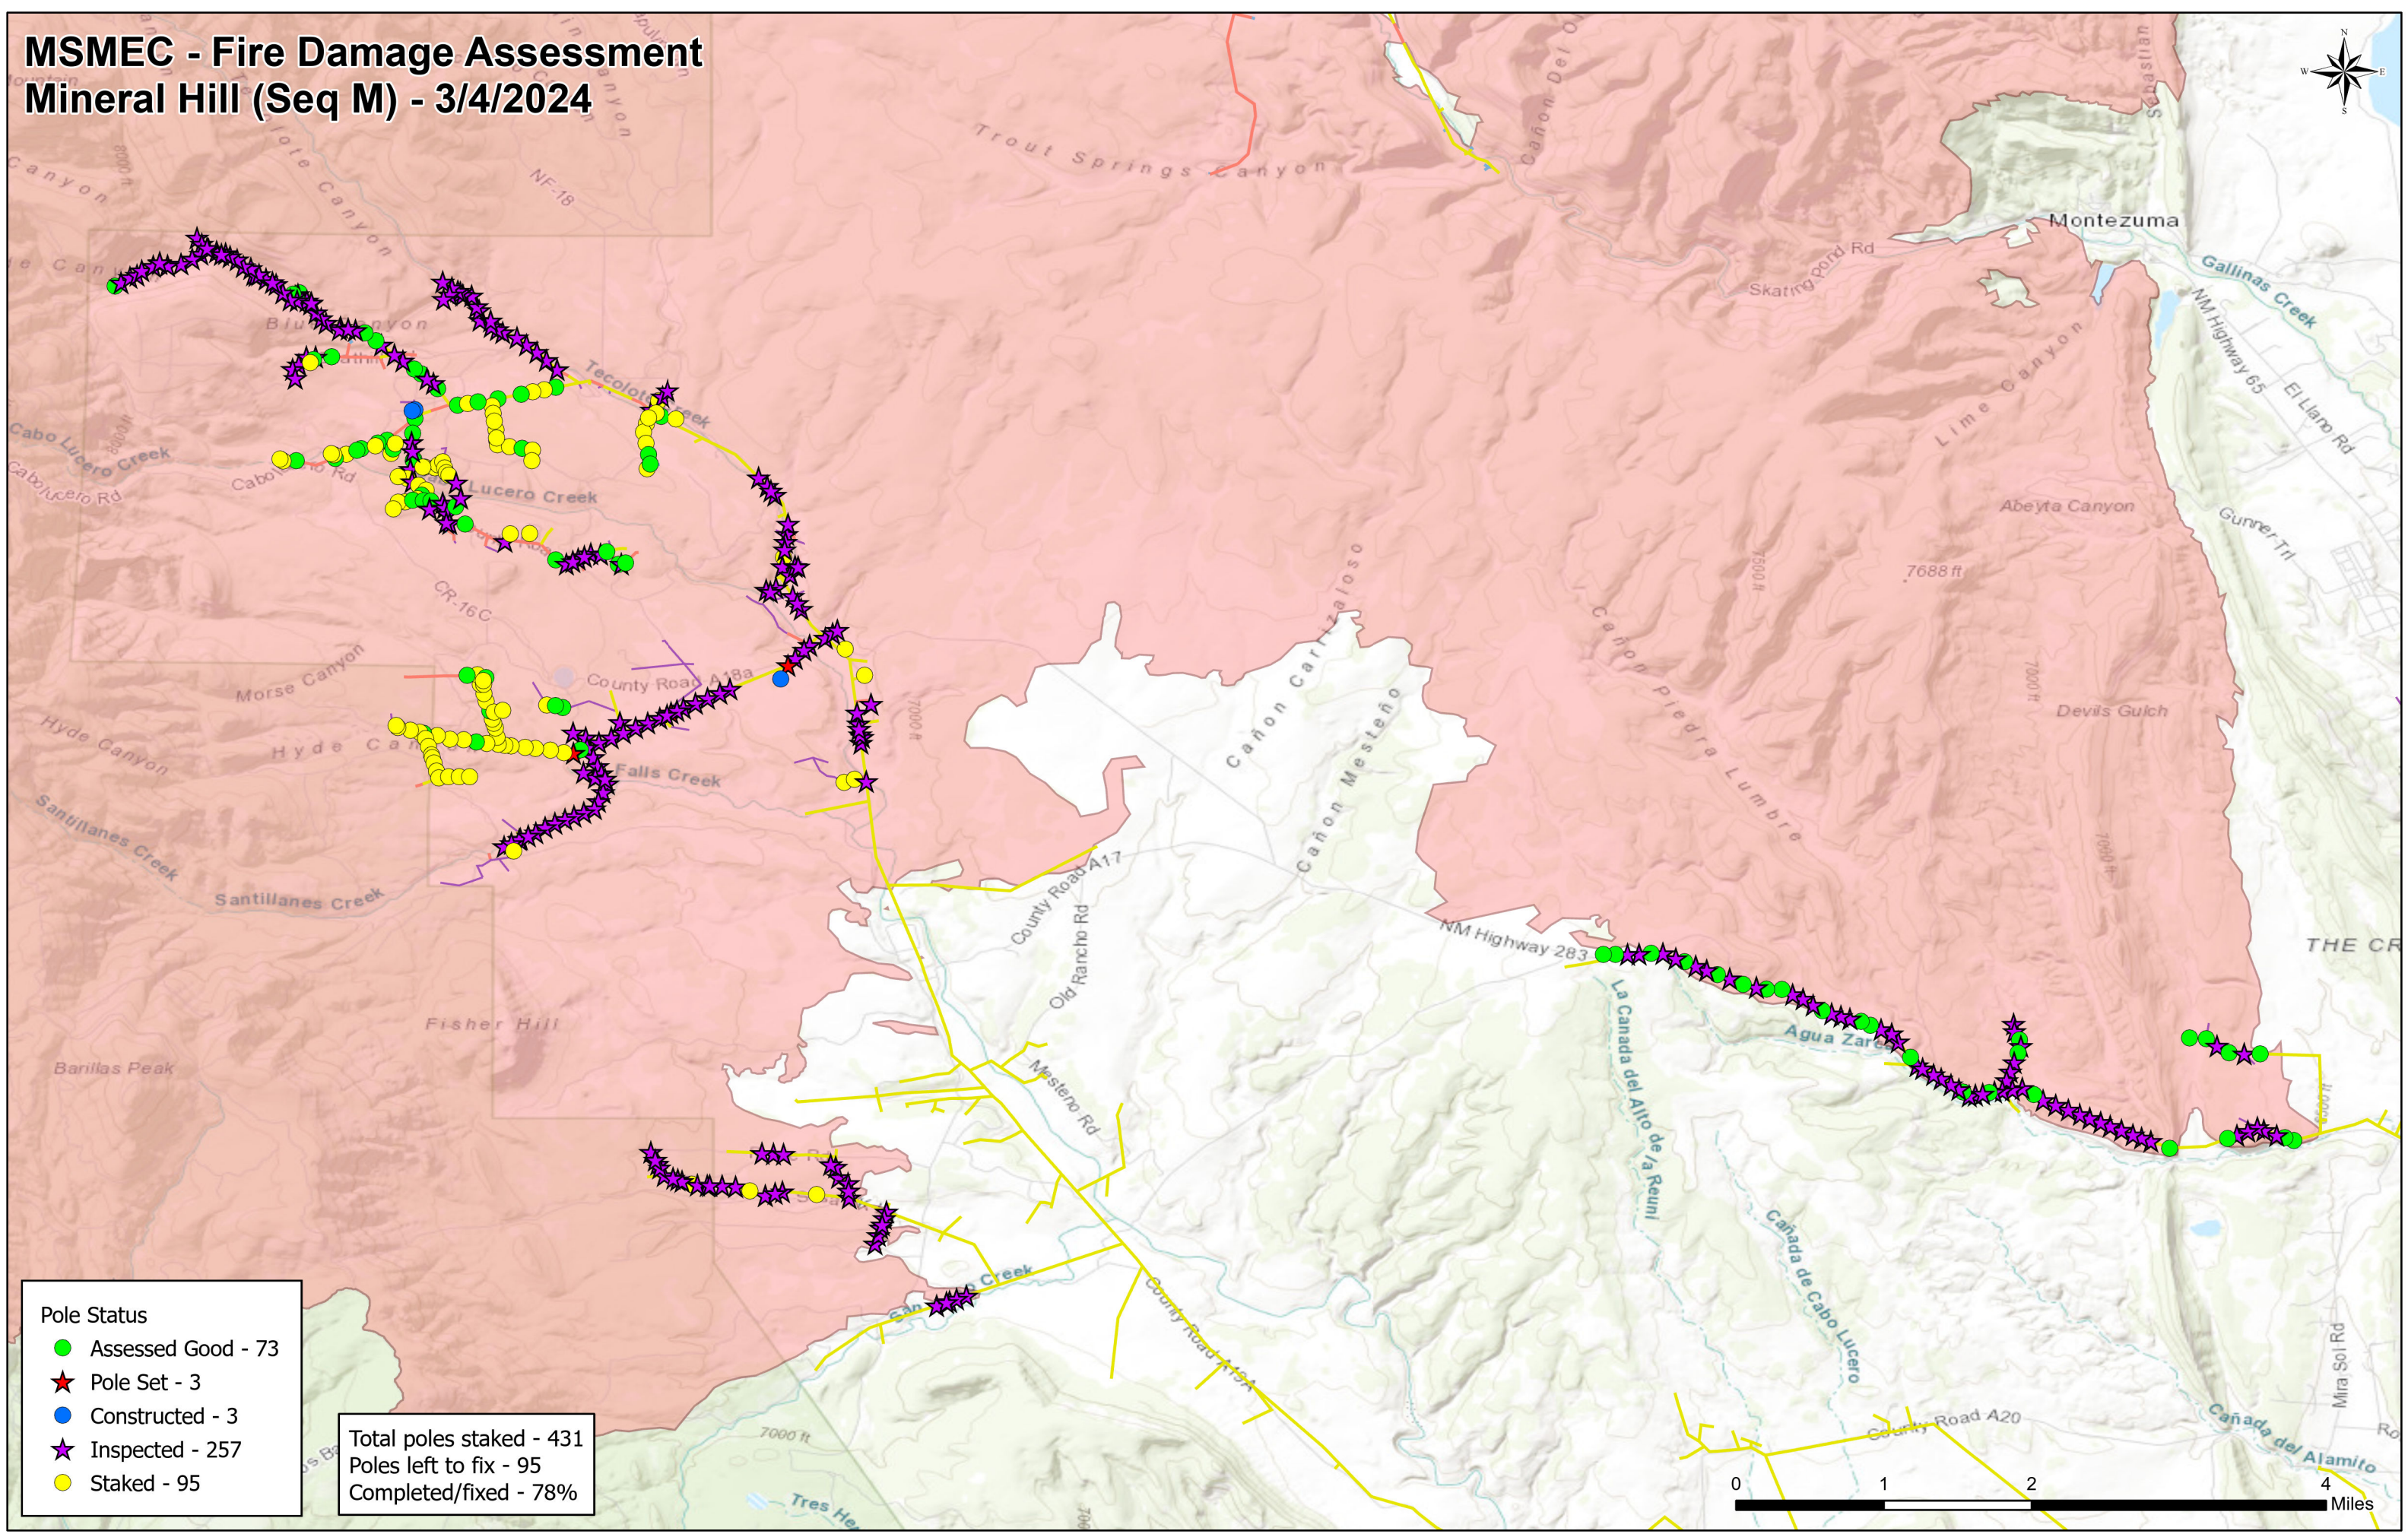
MSMEC - Fire Damage Assessment
Mineral Hill (Seq M) - 3/4/2024

- Pole Status
- Assessed Good - 73
 - Pole Set - 3
 - Constructed - 3
 - Inspected - 257
 - Staked - 95

Total poles staked - 431
Poles left to fix - 95
Completed/fixed - 78%

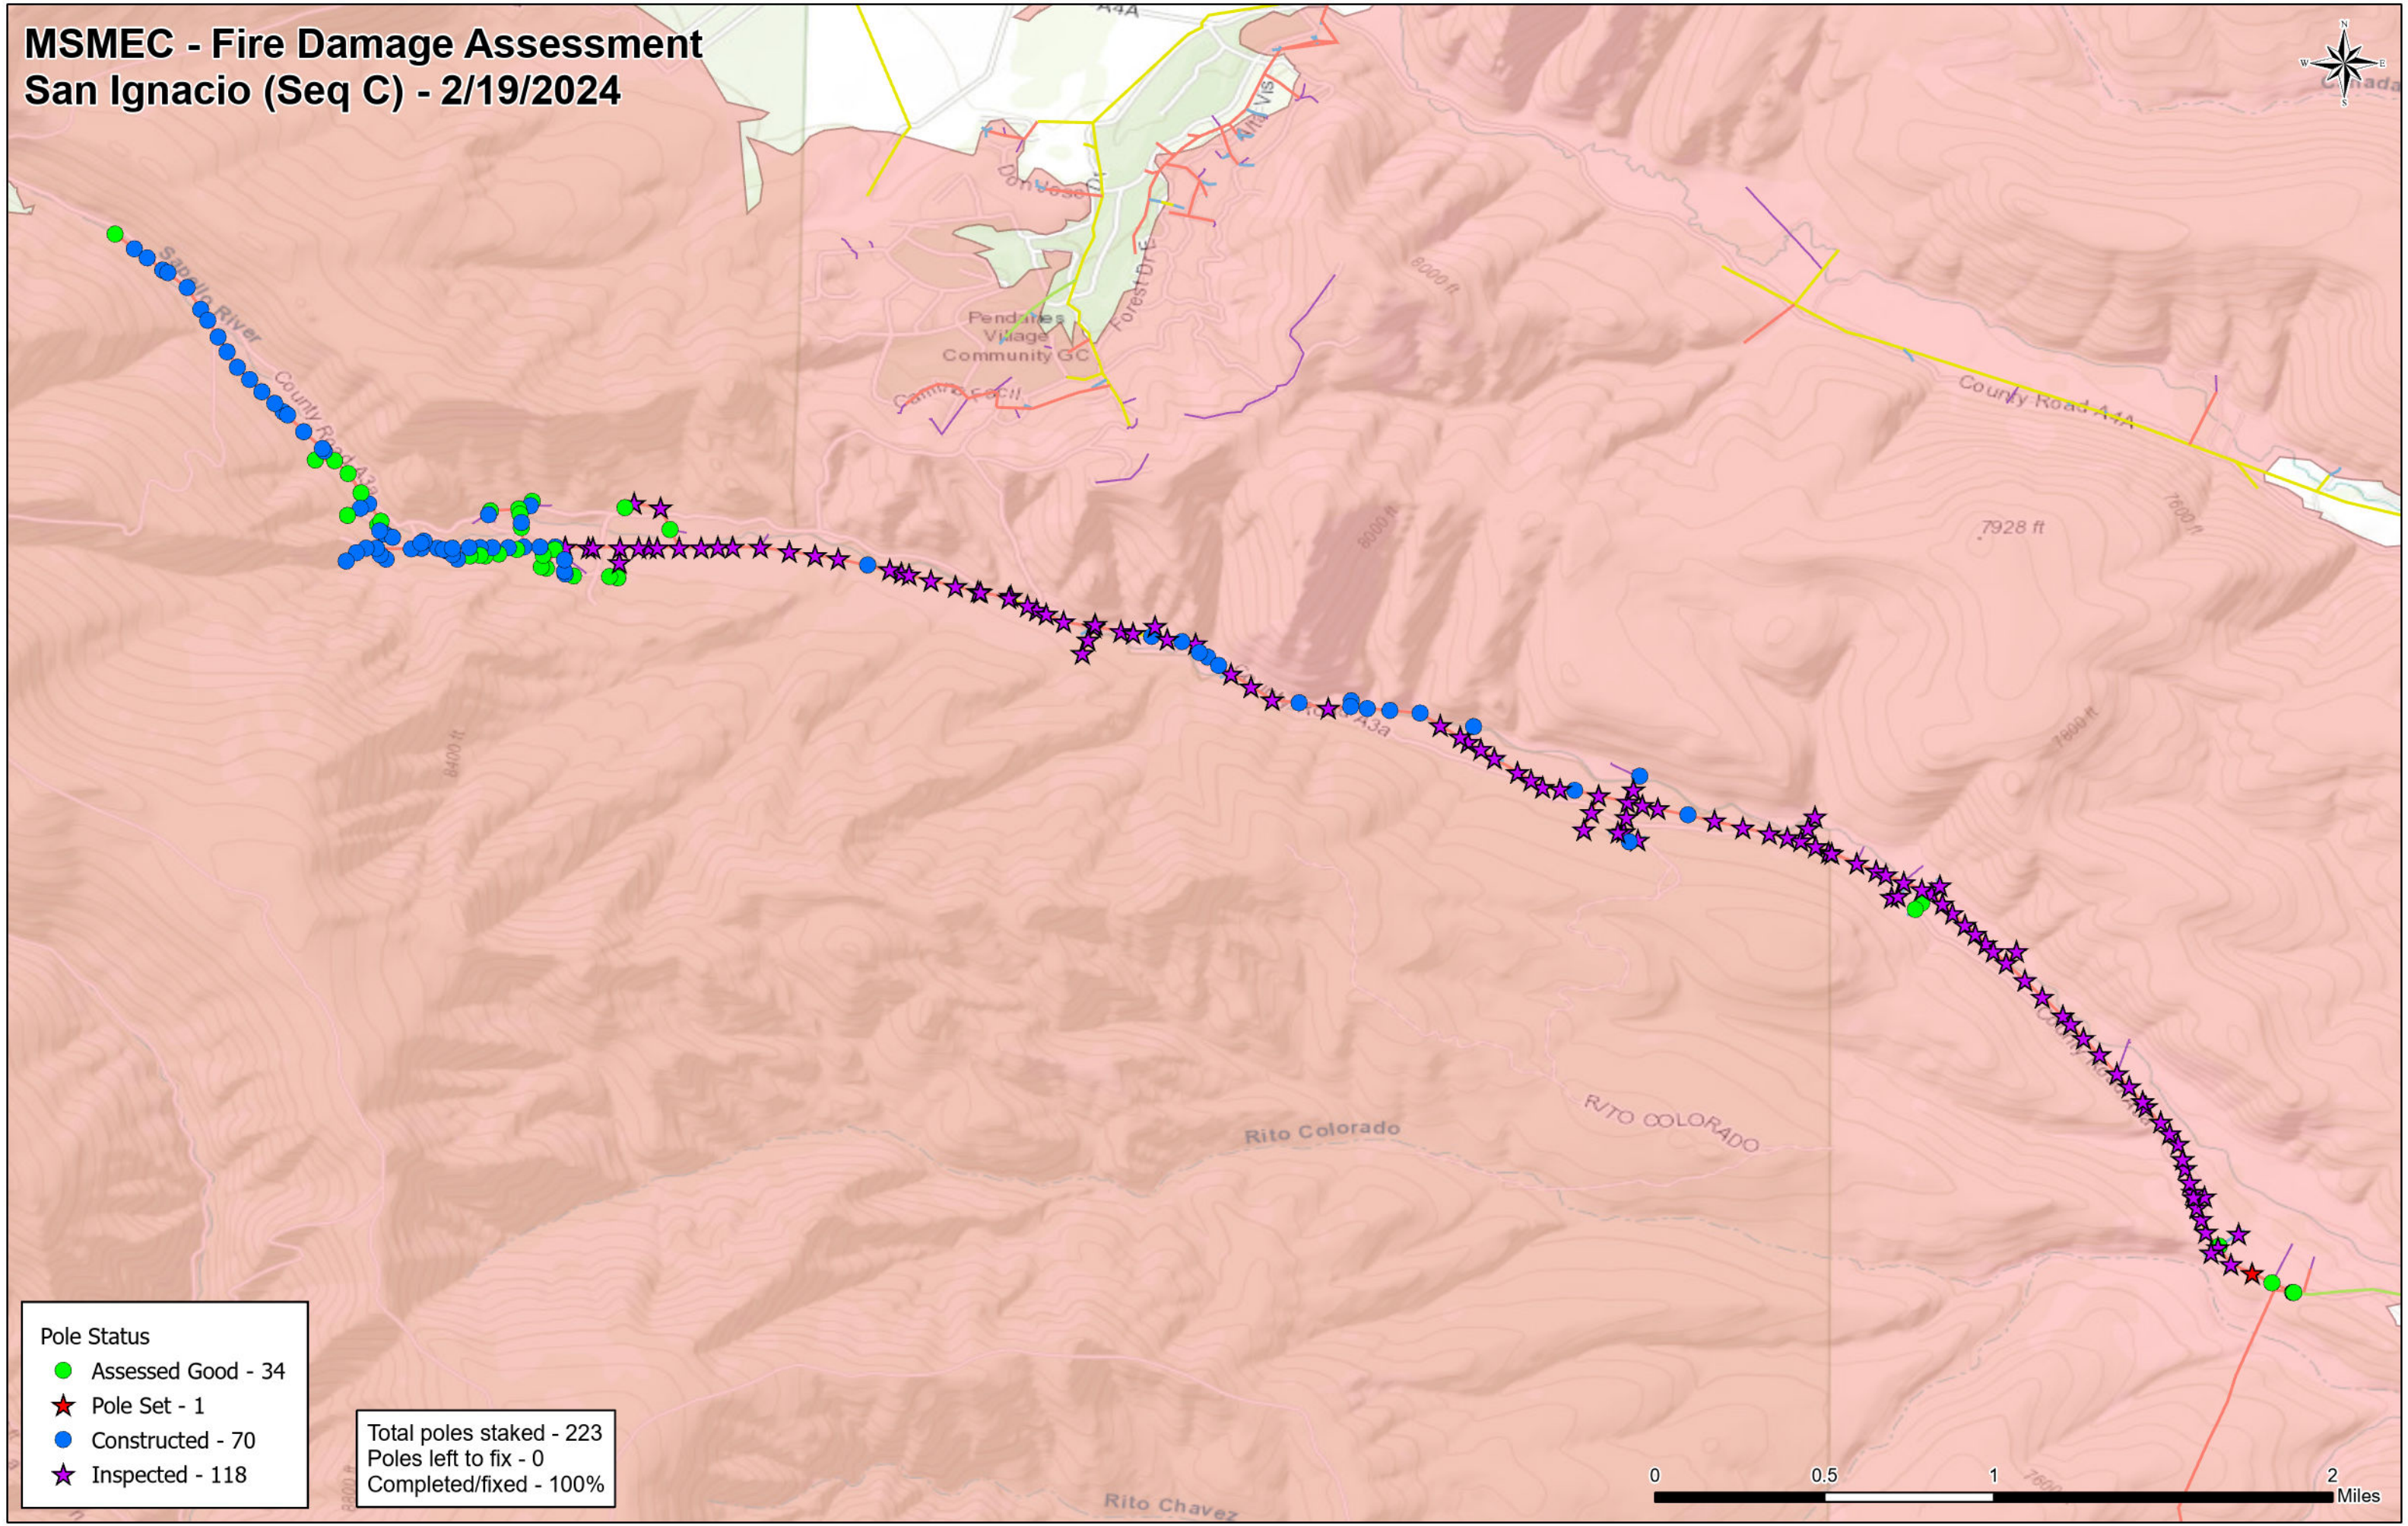
MSMEC - Fire Damage Assessment
San Ignacio (Seq C) - 2/19/2024

- Pole Status**
- Assessed Good - 34
 - Pole Set - 1
 - Constructed - 70
 - Inspected - 118

Total poles staked - 223
Poles left to fix - 0
Completed/fixed - 100%

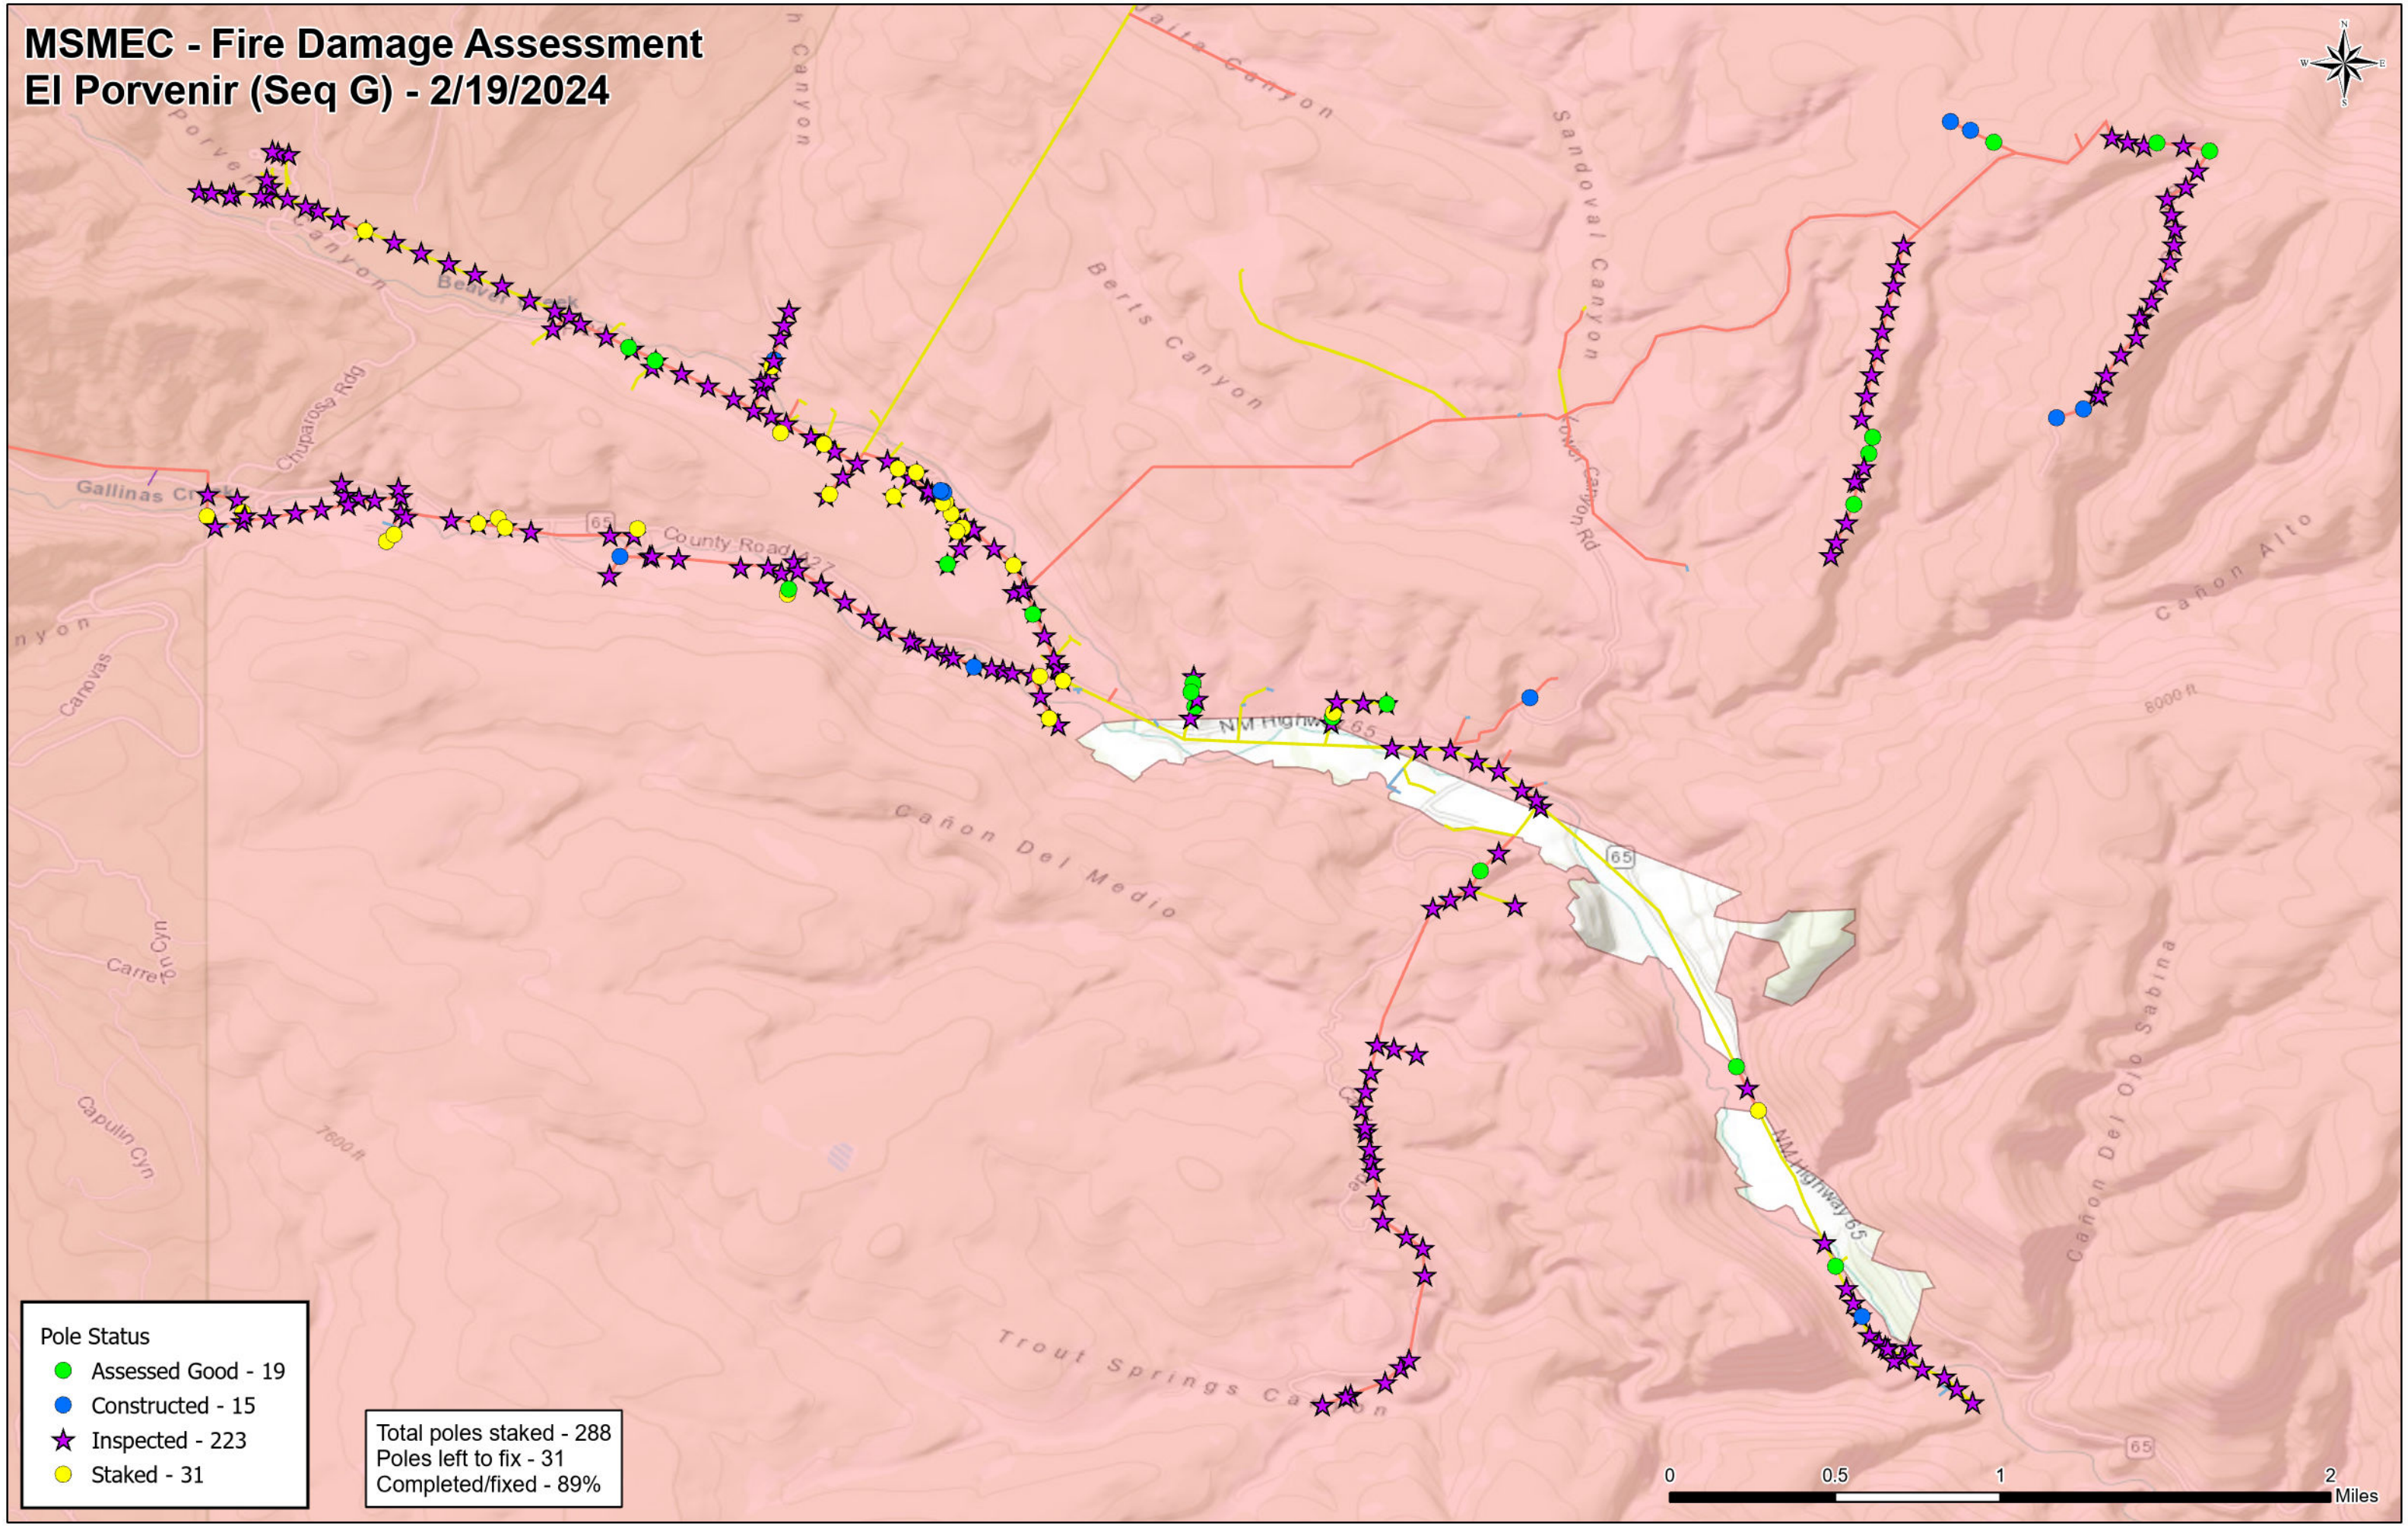
MSMEC - Fire Damage Assessment
El Porvenir (Seq G) - 2/19/2024

- Pole Status**
- Assessed Good - 19
 - Constructed - 15
 - ★ Inspected - 223
 - Staked - 31

Total poles staked - 288
Poles left to fix - 31
Completed/fixed - 89%

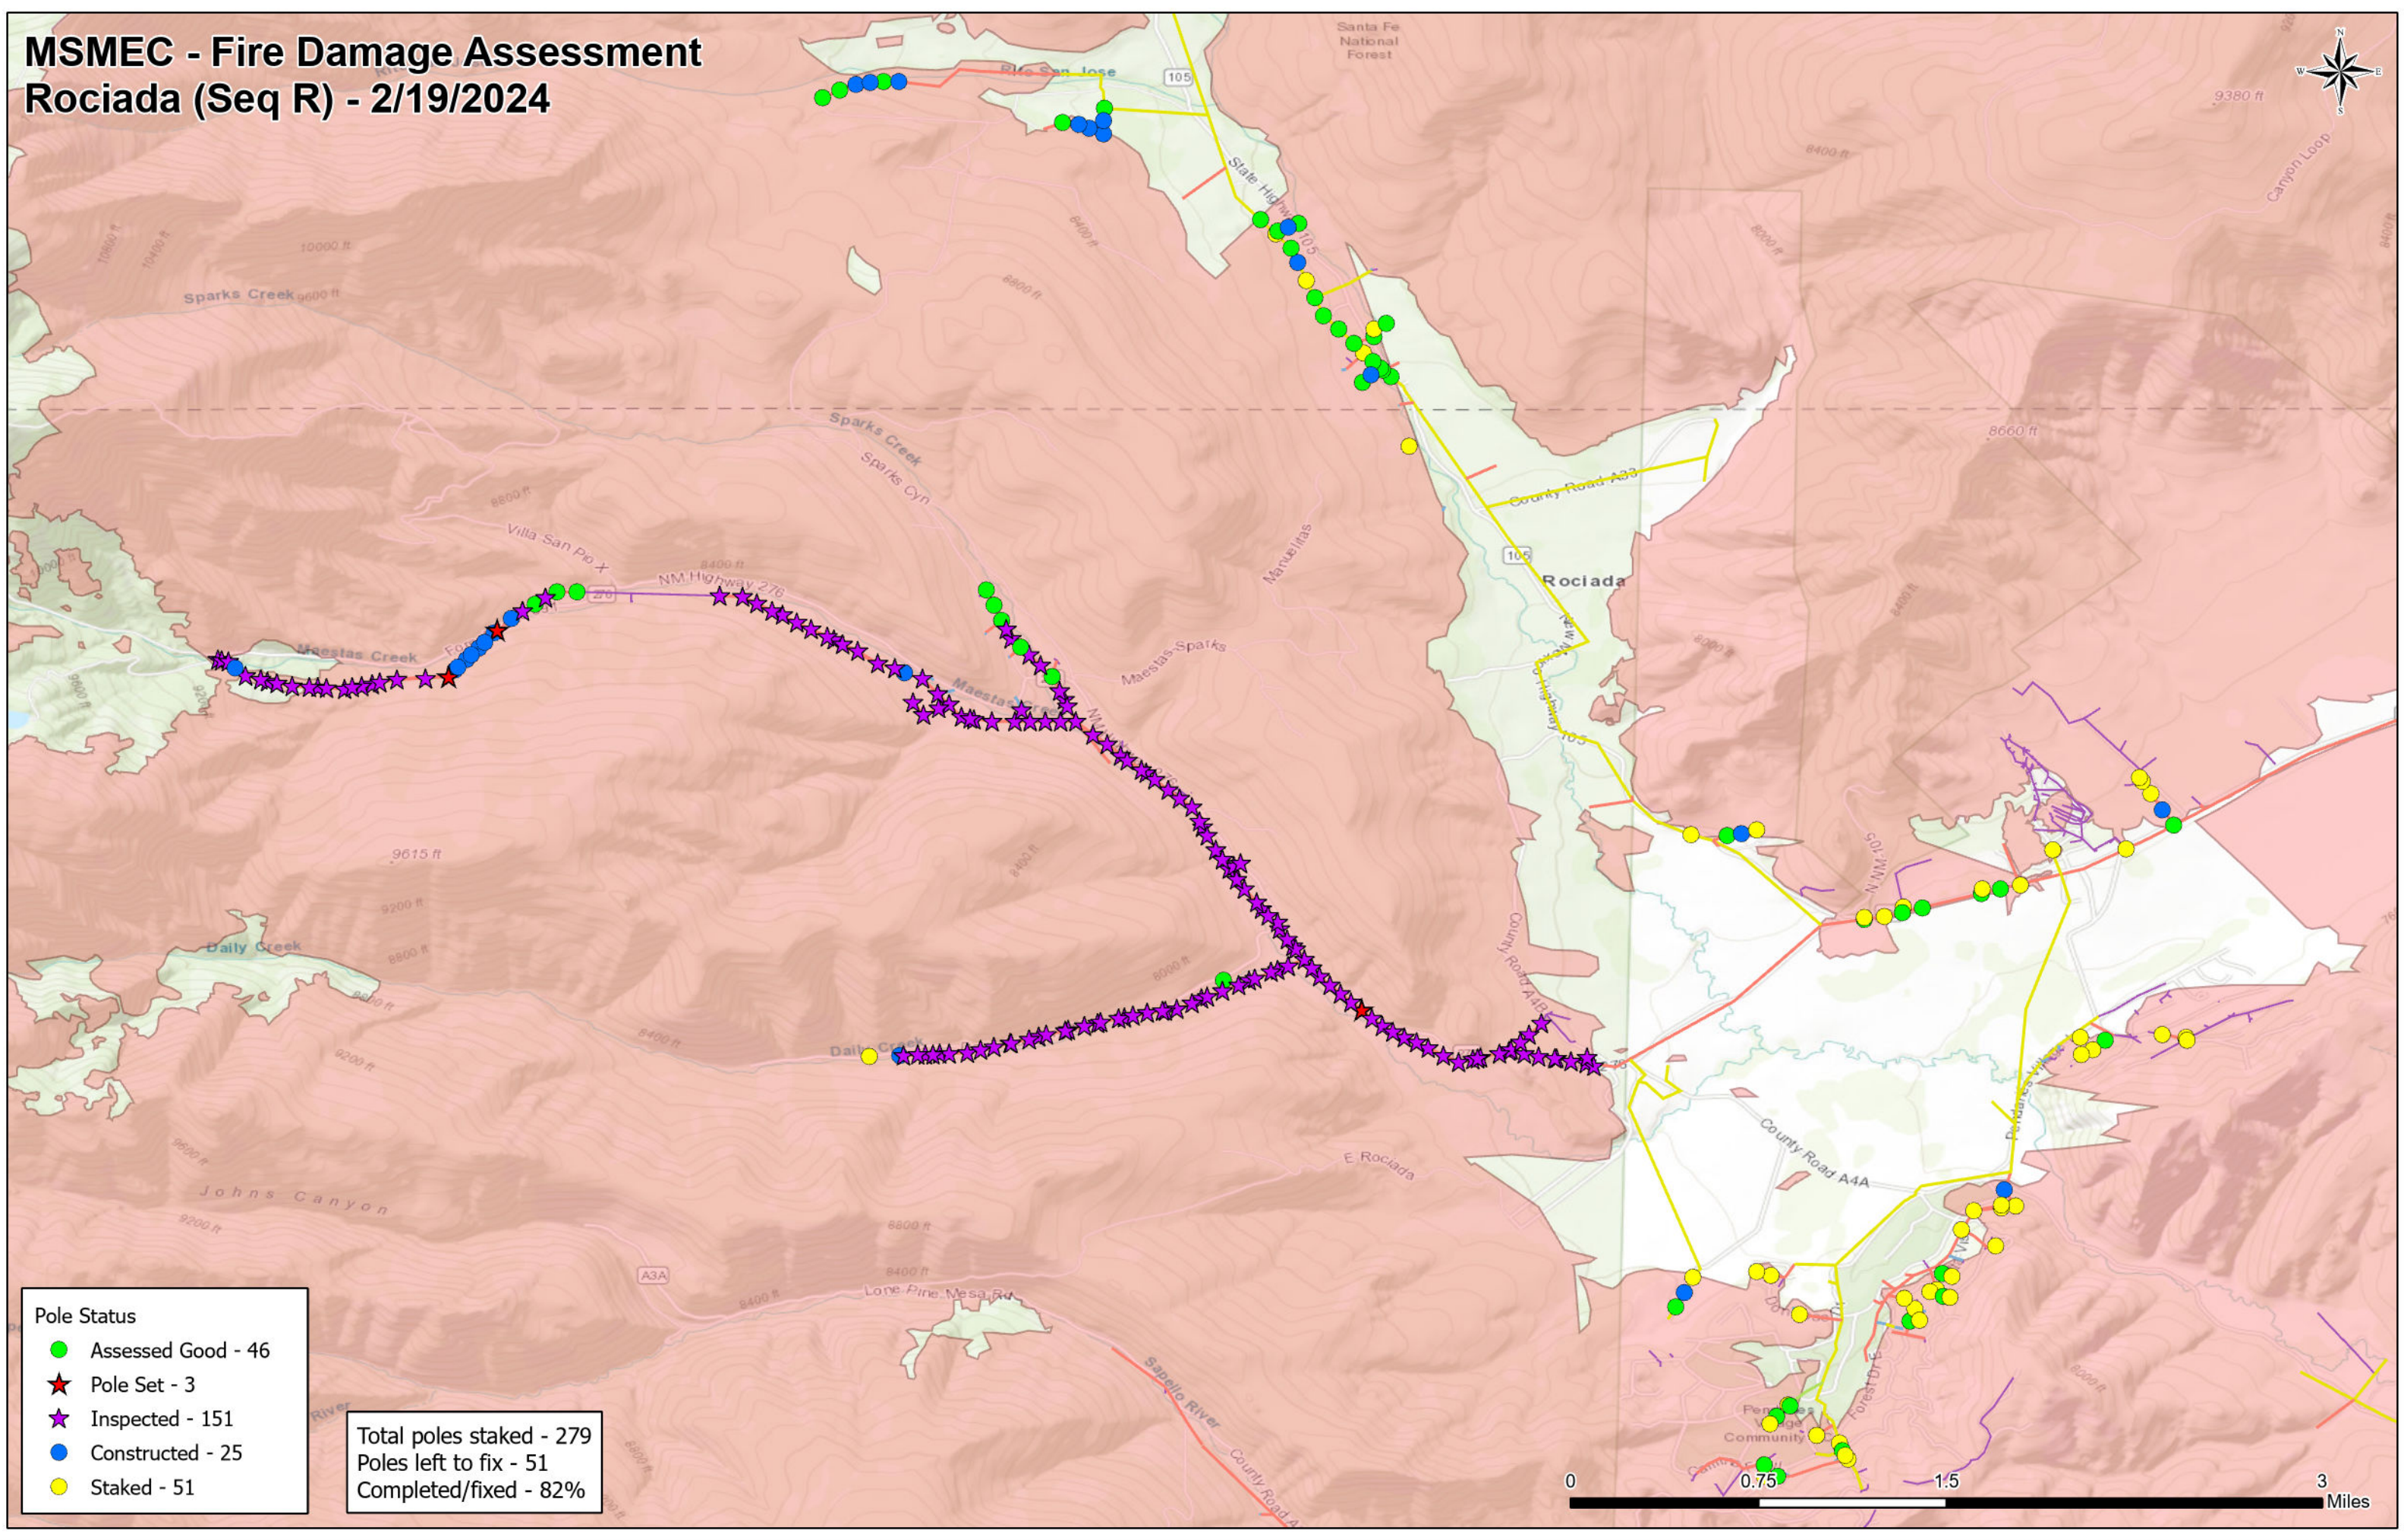
MSMEC - Fire Damage Assessment
Rociada (Seq R) - 2/19/2024

Pole Status

- Assessed Good - 46
- Pole Set - 3
- Inspected - 151
- Constructed - 25
- Staked - 51

Total poles staked - 279
Poles left to fix - 51
Completed/fixed - 82%
