MSMEC Pole Maps Update – Analysis Overview

Data analysis compiled through: Mar 3, 2024

Project completion total (entire burn area): **77% Completed**

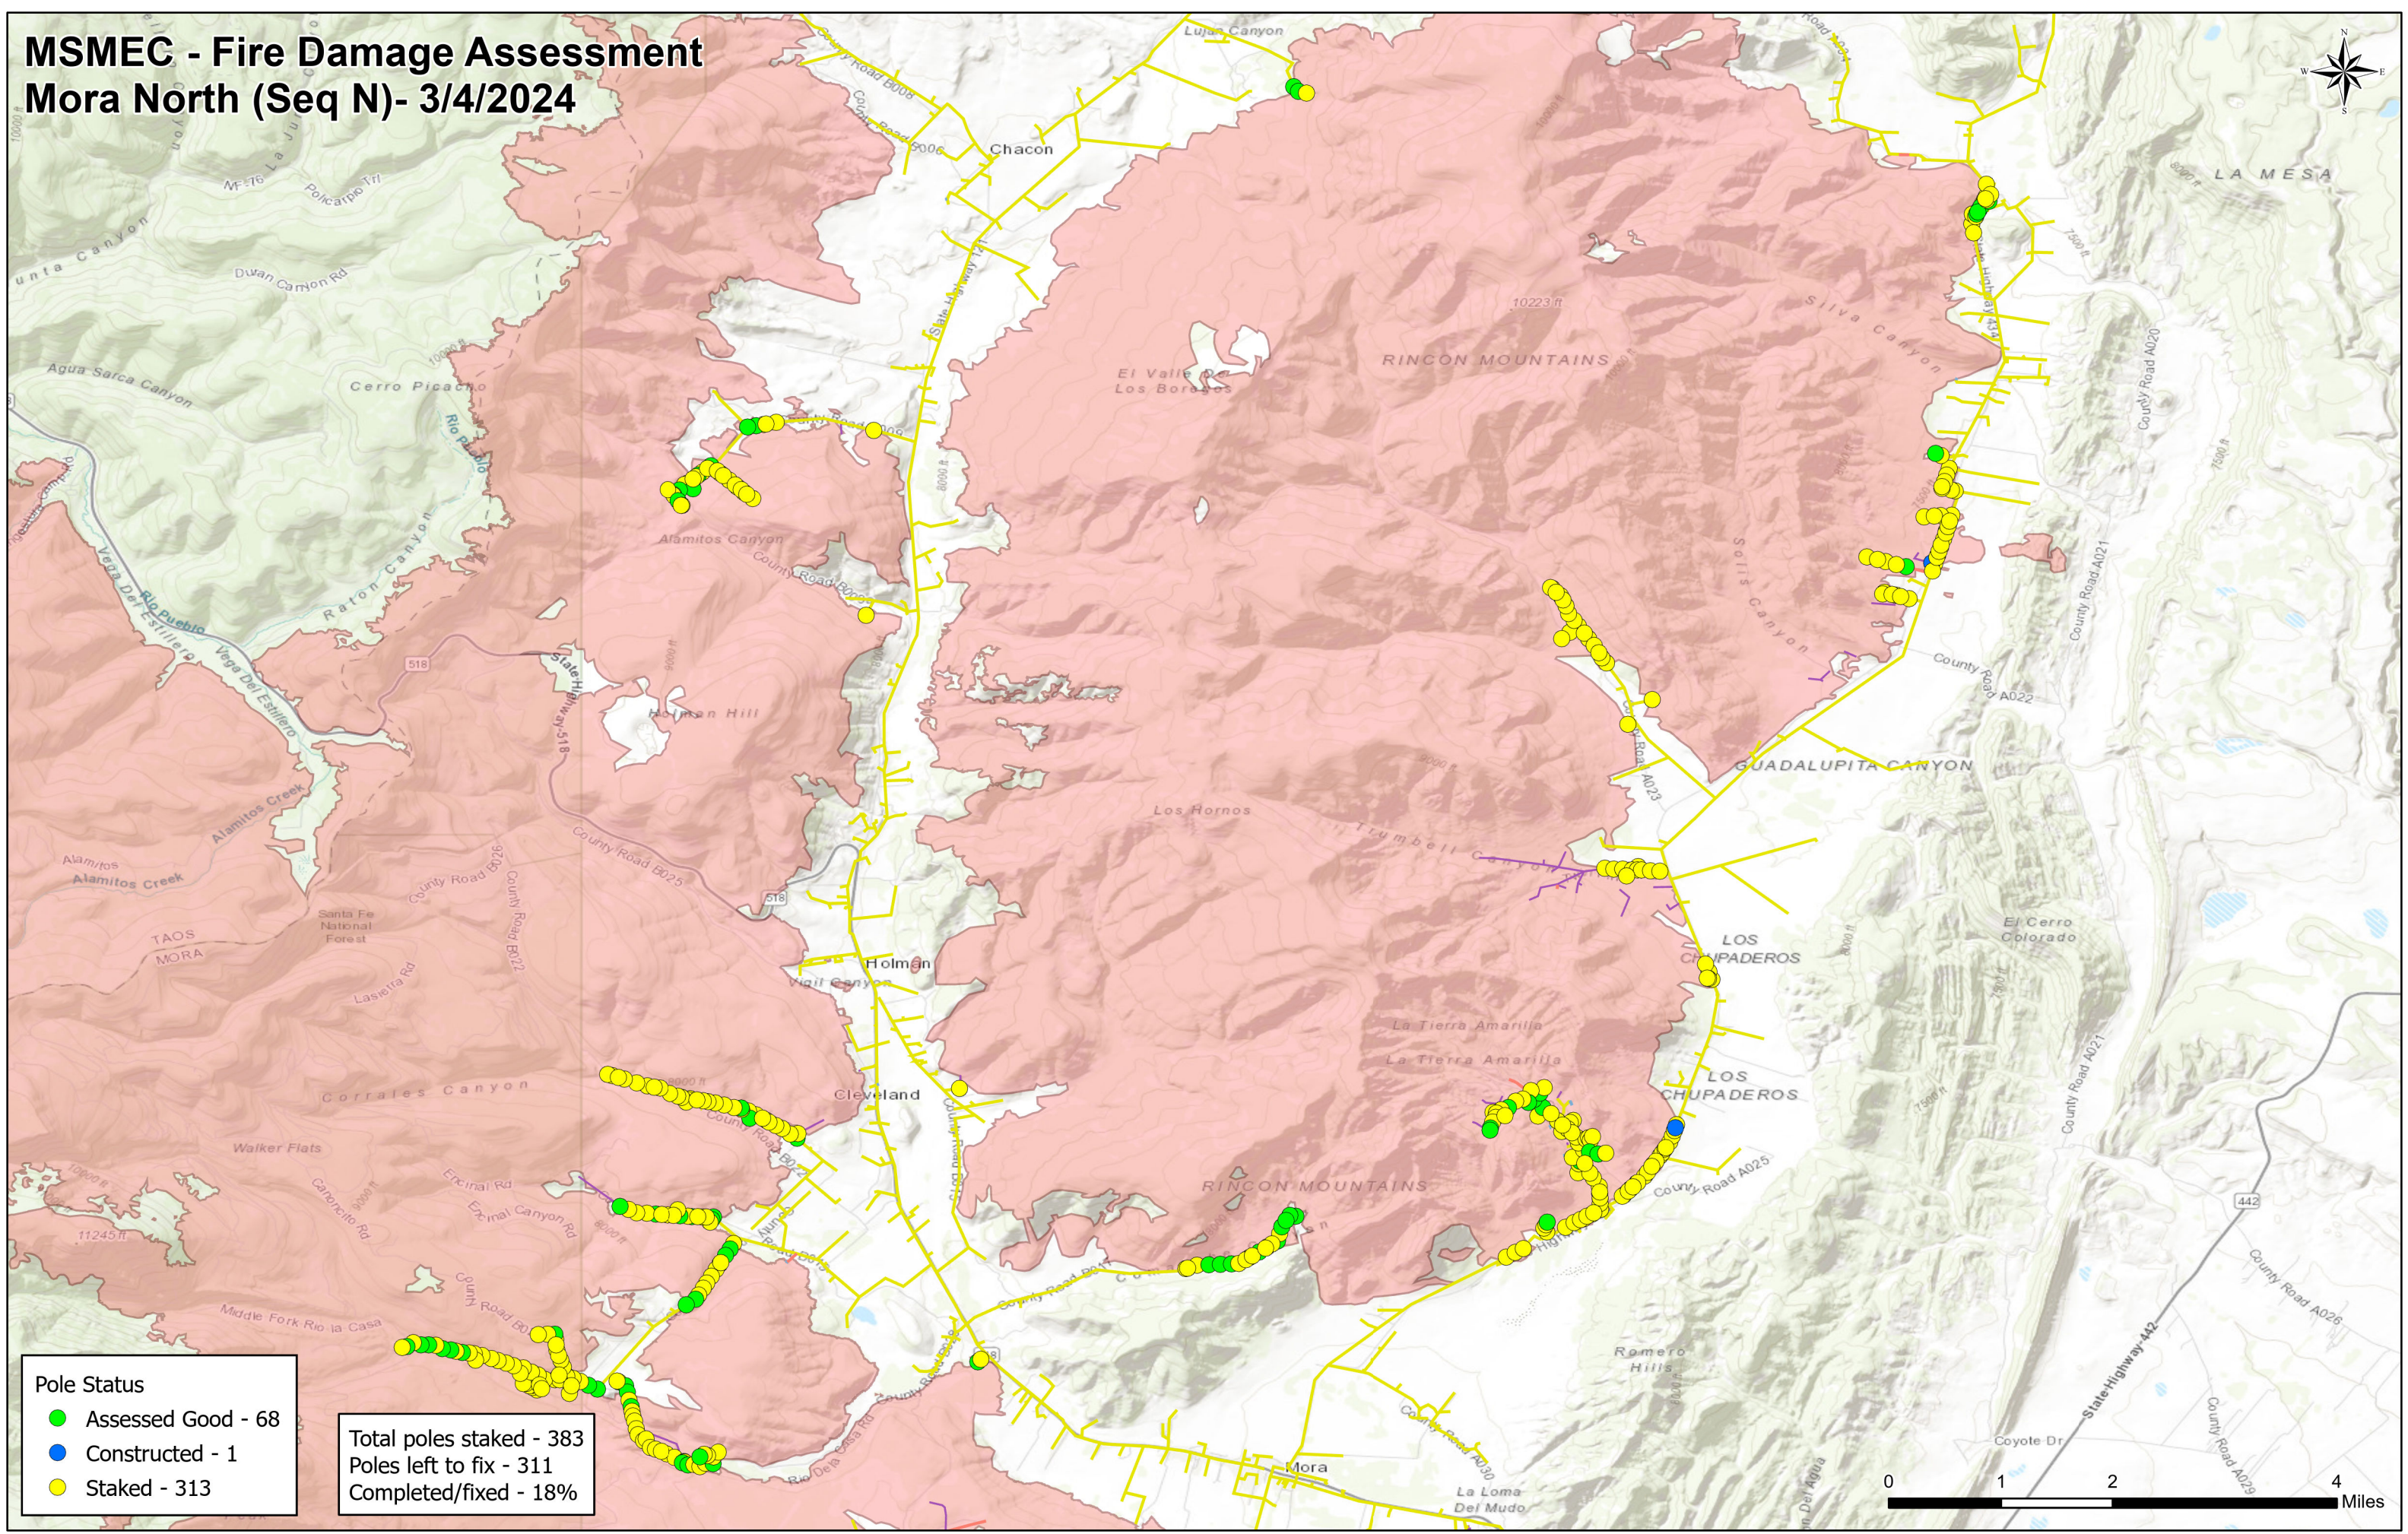
MSMEC - Fire Damage Assessment
Mora North (Seq N)- 3/4/2024

- Inspection progress in Las Dispensas 1
- Slight construction progress in Tierra Monte, Mineral Hill, Mora North
